| <b>Asbestos Re-inspection Report for:</b> (address) | STORE 243: Bristol Broadmead, 59 Broadmead, Bristol, Avon, BS1 3EA |
| <b>Date of Re-inspection visit:</b> | 2026-05-08 |
| <b>Consultancy Project No.</b> | 722971 |

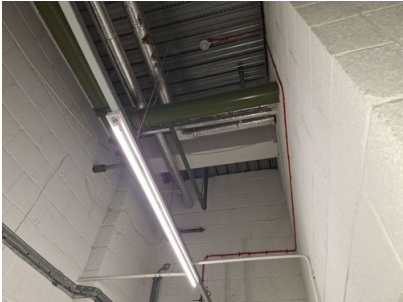
| 000243-323743 | N/A | 1 | 25 | | Lift lobby | high level beam cladding | AIB Insulating board | Strongly Presumed | 1 - Low Damage | 60 m2 Approx | 60 | P3 | Manage |

| Item ID | Item / Material Description | Item Location | Date | Image ID | Image (200x150) |
|---|---|---|---|---|---|
| 000243-323743 | high level beam cladding - insulating board | 025/Lift lobby | 2026-05-05 | 11699035 | |

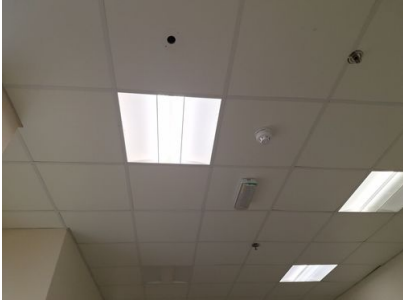
| 000243-158108 | N/A | 1 | 27 | | Stairwell | beam boxing | AIB Insulating board | Strongly Presumed | 1 - Low Damage | 16 Lm. | 16 | P2 | Restrict Access |

| Item ID | Item / Material Description | Item Location | Date | Image ID | Image (200x150) |
|---|---|---|---|---|---|
| 000243-158108 | beam boxing - insulating board | 027/Stairwell | 2026-05-05 | 11699037 | |

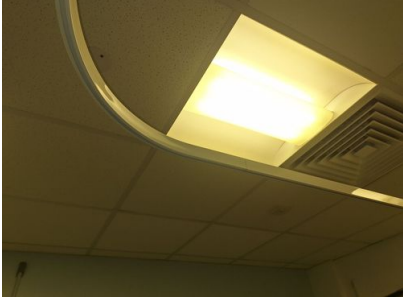
| 000243-323813 | N/A | 1 | 38 | | Consultation room | cladding to beams | AIB Insulating board | Strongly Presumed | 1 - Low Damage | 60 m2 Approx | 60 | P3 | Manage |

| Item ID | Item / Material Description | Item Location | Date | Image ID | Image (200x150) |
|---|---|---|---|---|---|
| 000243-323813 | cladding to beams - insulating board | 038/Consultation room | 2026-05-05 | 11699039 | |

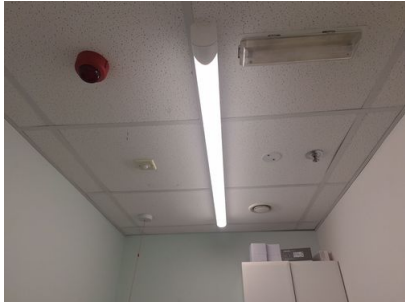
| 000243-323789 | N/A | 1 | 36 | | Staff WC | cladding to beams | AIB Insulating board | Strongly Presumed | 1 - Low Damage | 60 m2 Approx | 60 | P3 | Manage |

| 000243-323789 | cladding to beams - insulating board | 036/Staff WC | 2026-05-05 | 11699041 | |

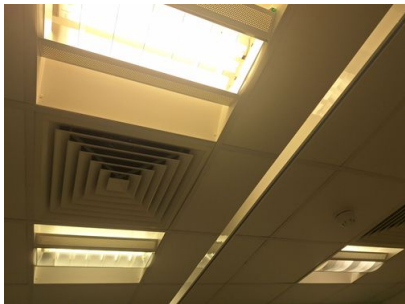
| 000243-323777 | N/A | 1 | 35 | | Consultation room | cladding to beams | AIB Insulating board | Strongly Presumed | 1 - Low Damage | 60 m2 Approx | 60 | P3 | Manage |

| 000243-323777 | cladding to beams - insulating board | 035/Consultation room | 2026-05-05 | 11699043 | |

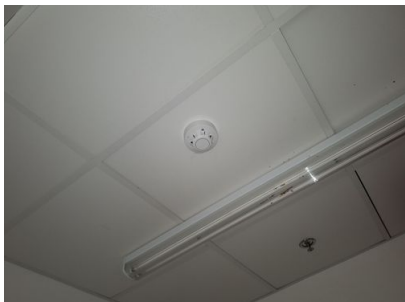
| 000243-323843 | N/A | 1 | 43 | | Cleaner's cupboard | cladding to beams | AIB Insulating board | Strongly Presumed | 1 - Low Damage | 60 m2 Approx | 60 | P3 | Manage |

| 000243-323843 | cladding to beams - insulating board | 043/Cleaner's cupboard | 2026-05-05 | 11699047 | |

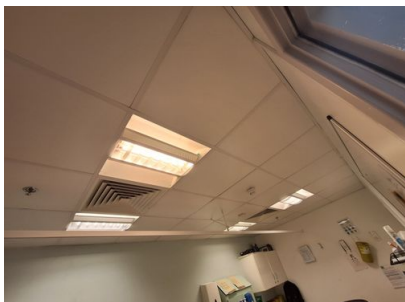
| 000243-62125 | N/A | 1 | 32 | | Surgery | cladding to beams | AIB Insulating board | Strongly Presumed | 1 - Low Damage | 60 m2 Approx | 60 | P3 | Manage |

| 000243-62125 | cladding to beams - insulating board | 032/Surgery | 2026-05-05 | 11699049 | |

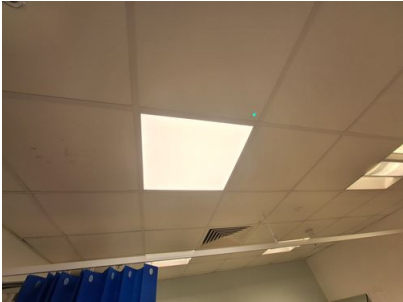
| 000243-323765 | N/A | 1 | 34 | | Consultation room | cladding to beams | AIB Insulating board | Strongly Presumed | 1 - Low Damage | 60 m2 Approx | 60 | P3 | Manage |

| 000243-323765 | cladding to beams - insulating board | 034/Consultation room | 2026-05-05 | 11699051 | |

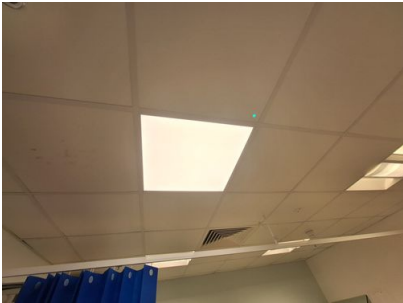
| 000243-323753 | N/A | 1 | 33 | | Consultation room | cladding to beams | AIB Insulating board | Strongly Presumed | 1 - Low Damage | 60 m2 Approx | 60 | P3 | Manage |

| 000243-323753 | cladding to beams - insulating board | 033/Consultation room | 2026-05-05 | 11699052 | |

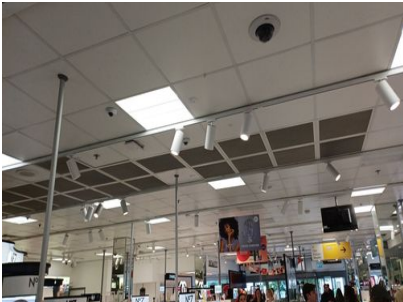
| Item No | comments | Floor | Room Reference | Sample Reference | Location Description | Item | Material Description | Asbestos | Condition | Quantity | Extent | Priority Rating | Management Action |
|---|---|---|---|---|---|---|---|---|---|---|---|---|---|
| 000243-62057 | N/A | 0 | 1 | 1 | Lower Ground sales area | Beam cladding | AIB Insulating board | Yes | 1 - Low Damage | est. 200Lm. | 0 | P3 | Manage |

| 000243-62057 | Beam cladding - AIB Insulating board | 001 /Lower Ground sales area | 2026-05-05 | 11713969 | |

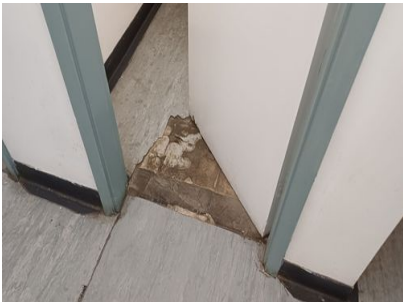
| 000243-122554 | N/A | 2 | 5 | W-217358/B001 | Male WC | tan floor tiles | BIT Bitumen | Yes | 1 - Low Damage | 6 Sqm. | 6 | P3 | Manage |

| 000243-122554 | tan floor tiles - floor tile without bitumen adhesive | 005/Male WC | 2026-05-08 | 11713960 | |

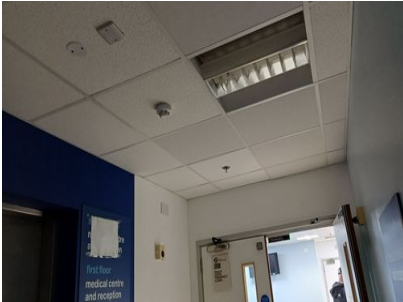
| 000243-323825 | present within ceiling void | 1 | 40 | | Lift lobby | cladding to beams | AIB Insulating board | Strongly Presumed | 1 - Low Damage | 60 m2 Approx | 60 | P3 | Manage |

| 000243-323825 | cladding to beams - insulating board | 040/Lift lobby | 2026-05-08 | 11713962 | |

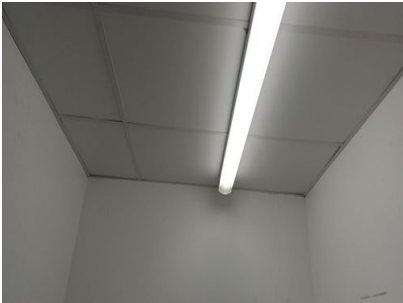
| 000243-323710 | N/A | 1 | 42 | | Disabled WC | cladding to beams | AIB Insulating board | Strongly Presumed | 1 - Low Damage | 60 m2 | 60 | P3 | Manage |

| 000243-323710 | cladding to beams - insulating board | 042/Disabled WC | 2026-05-08 | 11713964 | |

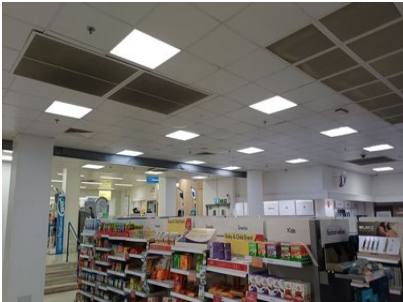
| 000243-157900 | N/A | 1 | 1 | 5 | Sales Area Lower level - Ceiling Void | Beam cladding | AIB Insulating board | Yes | 1 - Low Damage | 150 lm | 150 | P3 | Manage |

| 000243-157900 | Beam cladding - Insulating board | 001/Sales Area Lower level - Ceiling Void | 2026-05-08 | 11713967 | |

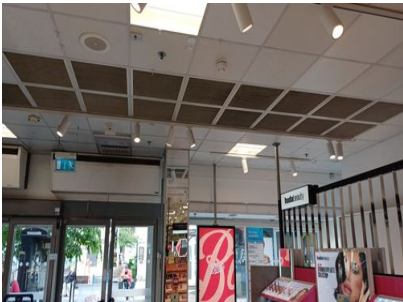
| Item No | comments | Floor | Room Reference | Sample Reference | Location Description | Item | Material Description | Asbestos | Condition | Quantity | Extent | Priority Rating | Management Action |
|---|---|---|---|---|---|---|---|---|---|---|---|---|---|
| 000243-250594 | N/A | 0 | 1 | 415150-1 | Lower Ground sales area | beam cladding to front of store | AIB Insulating board | Yes | 1 - Low Damage | 25 Sqm. | 25 | P3 | Manage |

| 000243-250594 | beam cladding to front of store - insulating board | 001 /Lower Ground sales area | 2026-05-08 | 11713970 | |

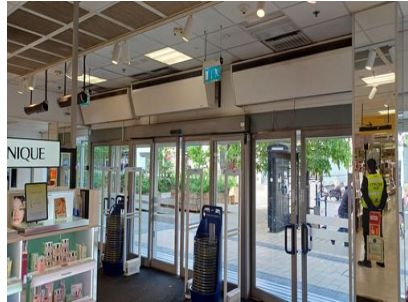
| Item No | comments | Floor | Room Reference | Sample Reference | Location Description | Item | Material Description | Asbestos | Condition | Quantity | Extent | Priority Rating | Management Action |
|---|---|---|---|---|---|---|---|---|---|---|---|---|---|
| 000243-250592 | N/A | 0 | 1 | 415150-3 | Lower Ground sales area | debris in void over street side entrance | ABC Asbestos cement | Yes | 2 - Medium Damage | Small Quantity Observed | 0 | P3 | Restrict Access |

| 000243-250592 | debris in void over street side entrance - cement | 001 /Lower Ground sales area | 2026-05-08 | 11713971 | |

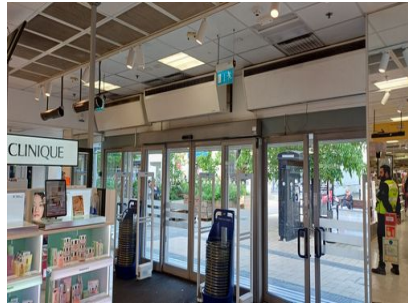
| Item No | comments | Floor | Room Reference | Sample Reference | Location Description | Item | Material Description | Asbestos | Condition | Quantity | Extent | Priority Rating | Management Action |
|---|---|---|---|---|---|---|---|---|---|---|---|---|---|
| 000243-250590 | N/A | 0 | 1 | 415150-1 | Lower Ground sales area | beam cladding in void above street side entrance | AIB Insulating board | Yes | 2 - Medium Damage | 2 Sqm. | 2 | P2 | Restrict Access |

| 000243-250590 | beam cladding in void above street side entrance - insulating board | 001 /Lower Ground sales area | 2026-05-08 | 11713972 | |

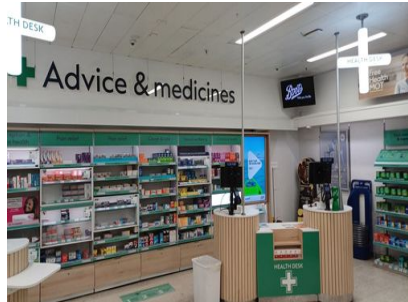
| Item No | comments | Floor | Room Reference | Sample Reference | Location Description | Item | Material Description | Asbestos | Condition | Quantity | Extent | Priority Rating | Management Action |
|---|---|---|---|---|---|---|---|---|---|---|---|---|---|
| 000243-246600 | N/A | 0 | 1 | | Lower Ground sales area | Beam cladding behind tills | AIB Insulating board | Presumed | 2 - Medium Damage | 4 Lm. | 4 | P3 | Restrict Access |

| 000243-246600 | Beam cladding behind tills - insulating board | 001 /Lower Ground sales area | 2026-05-08 | 11713973 | |

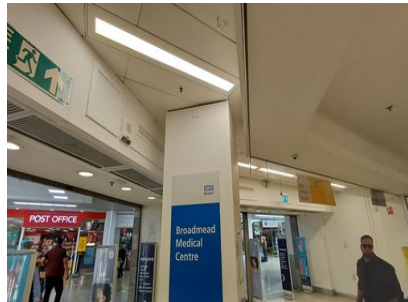
| Item No | comments | Floor | Room Reference | Sample Reference | Location Description | Item | Material Description | Asbestos | Condition | Quantity | Extent | Priority Rating | Management Action |
|---|---|---|---|---|---|---|---|---|---|---|---|---|---|
| 000243-205148 | N/A | 0 | 1 | | Sales Area Escalator 2 - Street Entrance | mastic around concrete column | MAS Mastics | Strongly Presumed | 1 - Low Damage | Small Quantity Observed | 0 | P3 | Manage |

| 000243-205148 | mastic around concrete column - mastic | 001/Sales Area Escalator 2 - Street Entrance | 2026-05-08 | 11713975 | |

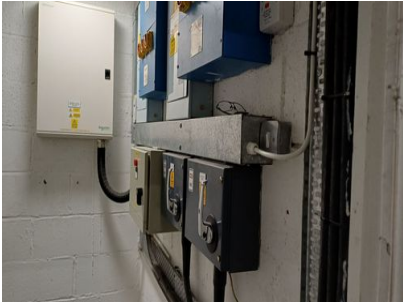
| Item No | comments | Floor | Room Reference | Sample Reference | Location Description | Item | Material Description | Asbestos | Condition | Quantity | Extent | Priority Rating | Management Action |
|---|---|---|---|---|---|---|---|---|---|---|---|---|---|
| 000243-185769 | N/A | 0 | 8 | | electrical switch room | Electrical switchgear | WOV Woven asbestos | Presumed | 1 - Low Damage | 4 No. | 4 | P3 | Manage |

| 000243-185769 | Electrical switchgear - woven product | 008/electrical switch room | 2026-05-08 | 11713977 | |

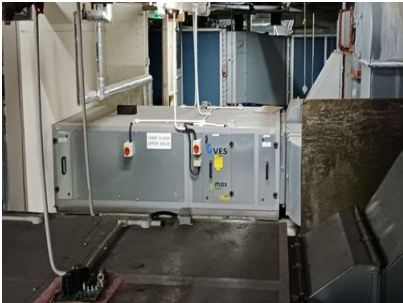
| 000243-273172 | N/A | 3 | 1 | 468899-3 | Plant Room | mastic to first floor upper sales ducting | MAS Mastics | Yes | 0 - Good | 20 Sqm. | 20 | P3 | Manage |

| 000243-273172 | mastic to first floor upper sales ducting - mastic | 001/Plant Room | 2026-05-08 | 11713979 | |

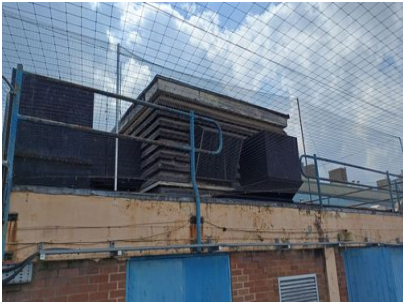
| 00243-17734 | N/A | External | 999 | 2 | External and upper roof | air con housing | ABC Asbestos cement | Yes | 2 - Medium Damage | Throughout Location | 0 | P3 | Manage |

| 00243-17734 | air con housing - cement | 999/External and upper roof | 2026-05-08 | 11713980 | |

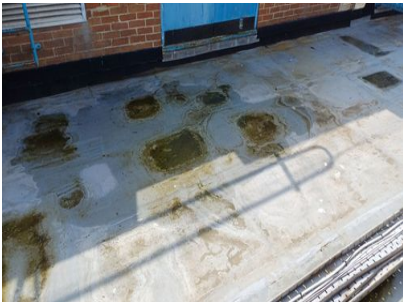
| | [23766547] . | External | 999 | 652739-1 | External and upper roof | debris to floor | CFP Cementitious fireproofing | Yes | 3 - High Damage | 2 m | 2 | P3 | Manage |

| 000243-23766547 | debris to floor - cement roof | 999/External and upper roof | 2026-05-08 | 11713981 | |

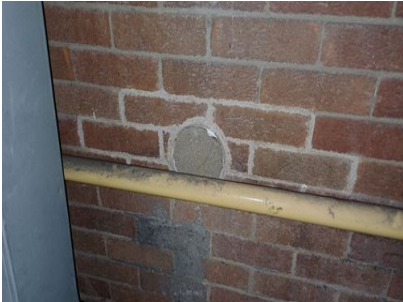
| 000243-273159 | N/A | 3 | 1 | 468899-1 | Plant Room | flue penetration | ABC Asbestos cement | Yes | 1 - Low Damage | 1 Sqm. | 1 | P3 | Manage |

| 000243-273159 | flue penetration - cement | 001/Plant Room | 2026-05-08 | 11713983 | |

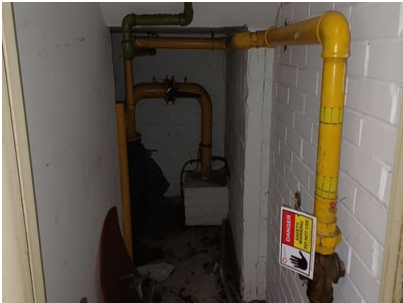
| Item No | comments | Floor | Room Reference | Sample Reference | Location Description | Item | Material Description | Asbestos | Condition | Quantity | Extent | Priority Rating | Management Action |
|---|---|---|---|---|---|---|---|---|---|---|---|---|---|
| 000243-158272 | N/A | 0 | 13 | | understairs gas meter room | gasket | ASK Gasket | Strongly Presumed | 1 - Low Damage | 2 No. | 2 | P3 | Manage |

| 000243-158272 | gasket - gasket | 013/understairs gas meter room | 2026-05-08 | 11713989 | |

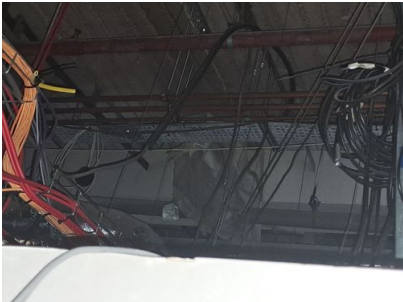
| 000243-323801 | N/A | 1 | 39 Consultation room 4 | | | cladding to beams | AIB Insulating board | Strongly Presumed | 1 - Low Damage | 8 m2 Approx | 8 | P3 | Manage |

| 000243-323801 | cladding to beams - insulating board | 039 Consultation room 4 | 2026-05-21 | 11777576 | |

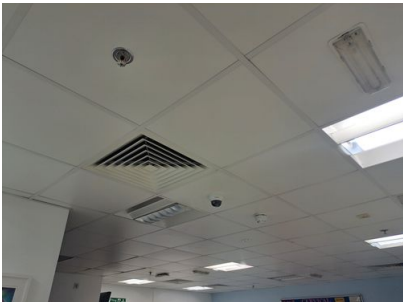
| 000243-323855 | N/A | 1 | 44 | | Waiting area | cladding to beams | AIB Insulating board | Strongly Presumed | 1 - Low Damage | 60 m2 Approx | 60 | P3 | Manage |

| 000243-323855 | cladding to beams - insulating board | 044/Waiting area | 2026-05-21 | 11777580 | |

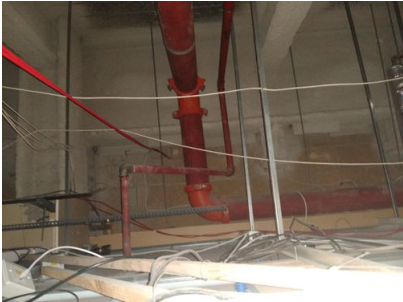
| Item No | comments | Floor | Room Reference | Sample Reference | Location Description | Item | Material Description | Asbestos | Condition | Quantity | Extent | Priority Rating | Management Action |
|---|---|---|---|---|---|---|---|---|---|---|---|---|---|
| 000243-158336 | This item is not accessible without damaging/removing fixtures and fittings | 1 | 1 | | Sales Area Lower level - Ceiling Void | insulating board in ceiling void behind tills | AIB Insulating board | Strongly Presumed | 2 - Medium Damage | Extent Indiscernible | 0 | P3 | Restrict Access |

| 000243-158336 | insulating board in ceiling void behind tills - insulating board | 001/Sales Area Lower level - Ceiling Void | 2026-05-21 | 11777596 | |
