# FIRE RISK ASSESSMENT

## Bristol Broadmead (243)

59 Broadmead, Bristol, BS1 3EA

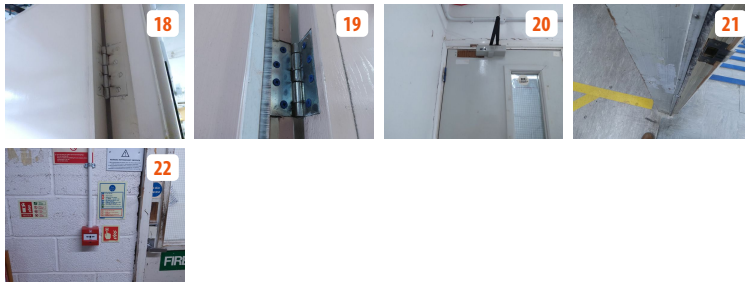
**WHY** The doors are to an older standard and have issues observed with the doors. No smoke seals, non fire rated hinges, doorstop missing, architrave missing.

Doors although not labelled with a certified fire door label to 30 minutes fire resistance did however on visual inspection appear to be of a solid nature and meeting the size requirements (44mm) to be considered as meeting the minimum requirements of a FD30 door.

**COMPLETED** It is recommended that a fire door register be introduced and that all doors are given a door number. Each door should be inspected by a specialist contractor and any faults, repairs or replacements should be carried out.
