Tetra Consulting Ltd  
**LEGIONELLA RISK ASSESSMENT**  
**(DOMESTIC SYSTEMS)**

168 Medical, Locking Road, Weston-Super-Mare  
BS23 3HQ

Report No: L-428625  
Date of assessment: 11/06/2025  
Recommended review date: June 2027

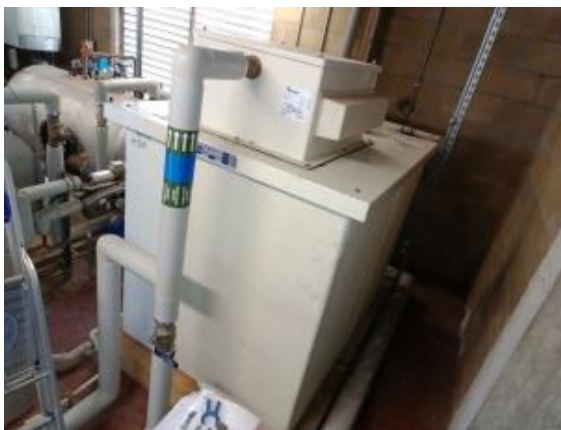
**Example of Cold Water Storage Tank 1**

There were no records to show that the total water turnover over of the cold water storage tank in a typical day has been monitored and recorded to establish there was reasonable flow through the tanks to prevent stagnation.

| P 2 Management Controls | | | |
|---|---|---|---|
| There were no records to show that the total water turnover over a typical day had been monitored and recorded to establish there was reasonable flow through the tanks to prevent stagnation. The volume of cold water stored should be minimised and should not normally be greater than one days water use. | Carry out an annual check on water consumption to ensure that there is suitable throughput to prevent stagnation. This can be done by fitting a water meter, or isolating the ball valve supplying the water and measuring the rate of water level drop within the tank. Whenever the building use pattern changes, this measurement should also be repeated.<br><b>*Outstanding from previous</b> | | |

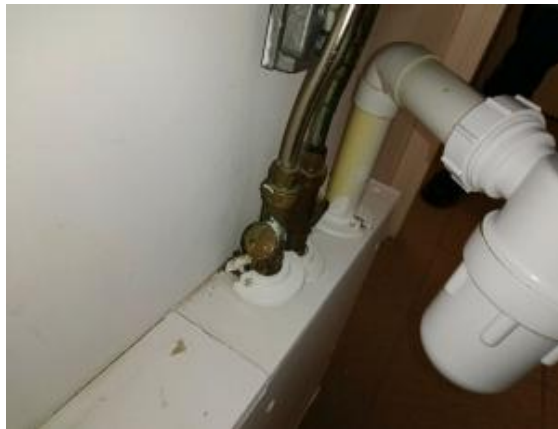
| <b>Location</b> | Ground Floor - Unisex toilet (office area) |

No records were available showing that the in line strainers, which are installed on the hot and cold pipework, are cleaned and descaled annually.

**Example of strainers.**

| P 2 Management Controls | | | |
|---|---|---|---|
| The log book did not have records showing that the in line strainers, which are installed on the hot and cold pipework, are cleaned and descaled annually. | Ensure the strainers are removed and cleaned and descaled as part of the annual service. Records of this work, should be recorded in the logbook, signed and dated by the person carrying out the work. | | |

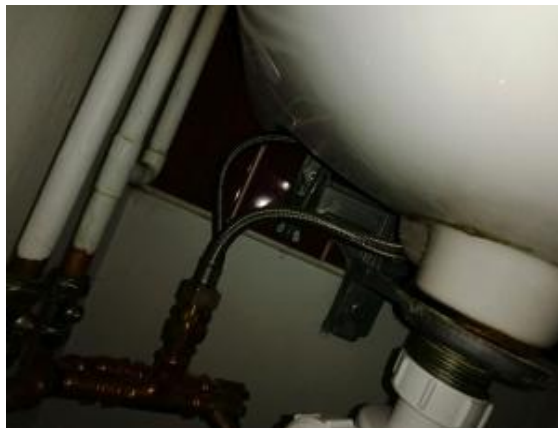
| <b>Location</b> | 1st floor - Staff toilet |

Flexible hoses were identified on the water system. Flexible hoses degrade over time and may provide harbourage for legionella and other bacteria.

Example of flexible hoses.

Where positive legionella results are returned; as part of the remedial works, check the condition of flexible hoses and replace as necessary.

Strainers and flow restrictors should be removed and inspected for evidence of EPDM / rubber particles. The tap should also be opened fully to identify if discoloured water or particles are discharged, which may be an indication that the flexible hose has degraded and requires changing.

When purchasing flexible hoses, the hoses must be WRAS approved. Best practice is to consult the WRAS directory for any product that may come into contact with the water system.

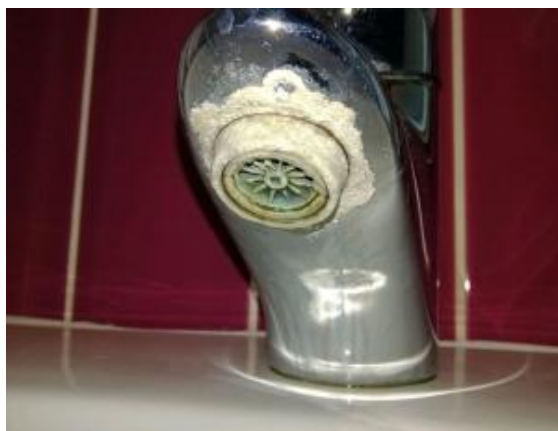
| <b>Location</b> | 2nd Floor - Staff toilet |

Scale was identified on outlets and aerators in various locations.

Example of scale present on tap outlet and aerator.

| P 2 Management Controls | | | |
|---|---|---|---|
| In general, tap outlets were free from scale deposits. However, a small number of tap outlets were noted to be harbouring scale deposits (see the Other Sources table in Section 3 for specific locations). | All tap outlets should be maintained free from scale deposits. Ensure the scaled taps are included in the routine cleaning / descaling programme. | | |
| In general aerators were free from sediment and scale deposits. However, a small number of aerators were noted to be harbouring sediment and/or scale deposits (see the Other Sources table in Section 3 for specific locations). | All aerators should be maintained free from sediment and scale deposits. Ensure the aerators are included in the routine cleaning / descaling programme. | | |

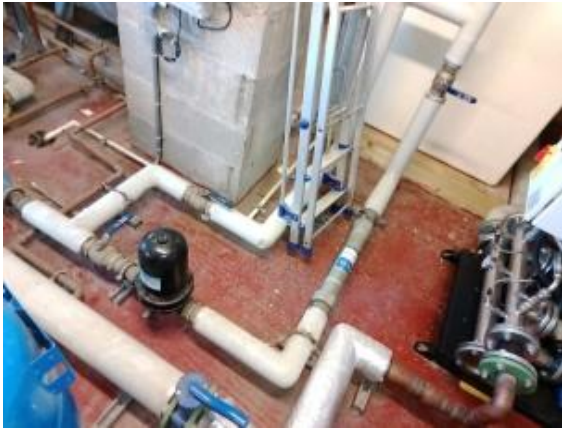
Bypass pipework for cold water storage tank was identified as being as deadleg on the system.

| Location | Photo |
|---|---|
| Roof - Plant room Deadleg 1 | <p>Example of Deadleg 1.<br/>(Bypass pipework)</p> |

| P 2 Deadleg 2<br>Roof-Plant room; | | | |
|---|---|---|---|
| The cold water tank bypass is creating a deadleg where water could stagnate. * | The bypass should be opened and left running for at least 5 minutes once per week. | | |

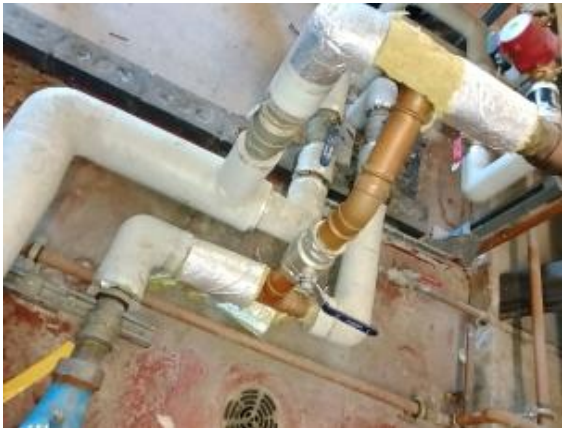
The calorifier cylinder water bypass was identified as being as deadleg on the system.

| Location | Photo |
|---|---|
| Roof - Plant room Deadleg 4 | <p>Example of Deadleg 2.<br/>(Bypass pipework)</p> |

| P 2 Deadleg 4<br>Roof-Plant room; | | | |
|---|---|---|---|
| The calorifier water bypass is creating a deadleg where water could stagnate. * | The bypass should be opened and left running for at least 5 minutes once per week. | | |
