# LEGIONELLA RISK ASSESSMENT

Greenway Community Practice  
Greystoke Avenue  
Southmead  
Bristol  
BS10 6AF

16th May 2025

37173 - 2336

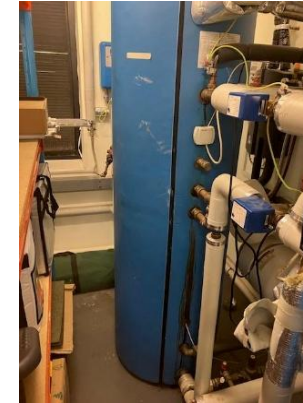
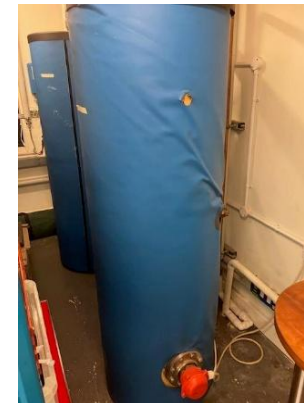
| | HWG1 | First Floor Plant Room | HWG2 | Fist Floor Plant Room |
|---|---|---|---|---|
| Body temperature is acceptable | | 50 | | 61 |
| Flow temperature is acceptable | | 50 | | 61 |
| Return temperature is acceptable | | 50 | | 53 |
| Stratification is occuring within unit | | Yes | | Yes |

Photos shows the external condition of the hot water generators

- 4) The hot water generators must be subject to an annual flush and removal of sediment and debris from the base. A water sample should also be obtained to ascertain the internal quality and condition of the Hot Water Generators.

- 5) The hot water generator 2 flow temperature was found to be at or above 60°C at the time of the assessment. Flow pipe temperatures are required to be modulated as close as possible to 60°C in order to effectively eradicate bacteria.

- 6) The hot water generator 1 flow temperature was found to be below 55°C at the time of the assessment. Flow pipe temperatures are required to be modulated as close as possible to 60°C in order to effectively eradicate bacteria.

*The hot water generator thermostat setting must be adjusted as a matter of priority.*
