Tetra Consulting Ltd  
**LEGIONELLA RISK ASSESSMENT**  
**(DOMESTIC SYSTEMS)**

168 Medical, Locking Road, Weston-Super-Mare  
BS23 3HQ

Report No: L-428625  
Date of assessment: 11/06/2025  
Recommended review date: June 2027

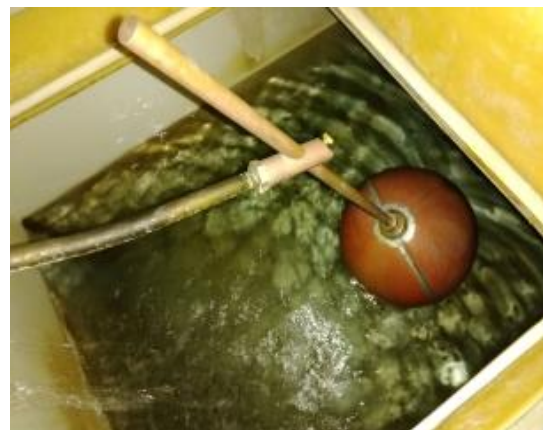
| Is there evidence of slime / biological contamination: | No | Is the tank in good physical condition: | Yes |

**Example of Cold Water Storage Tank 1 internal view**

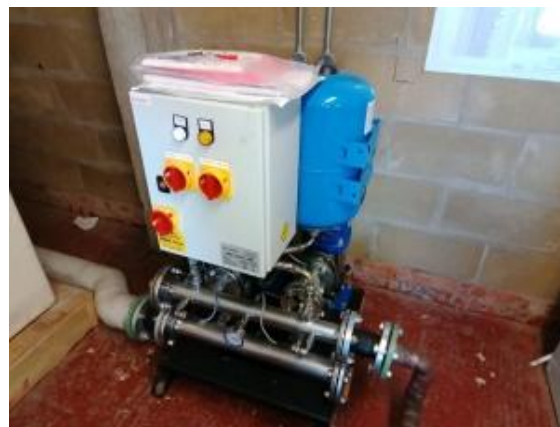
**Example of twin pumps associated with Cold Water Storage Tank 1**

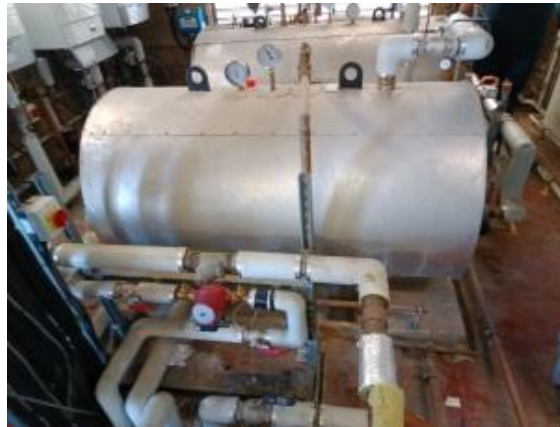
**Example of Calorifier Cylinder 1**

| Calorifier storage / flow Temperature (°C): | 60.2 | Is the calorifier storage / flow at a suitable temperature? | The hot water supply temperature from the calorifier was correct, being at 60°C |
| Return Temperature (°C): | 51.5 | Is the calorifier return at a suitable temperature? | The hot water return temperature to the calorifier was correct, being above 50°C . |

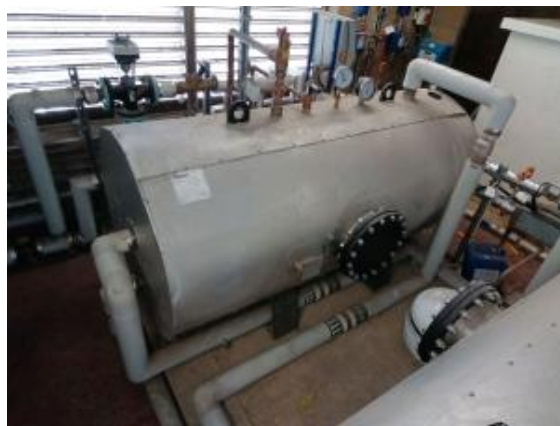
**Example of Calorifier 2**

| Calorifier storage / flow Temperature (°C): | 60.6 | Is the calorifier storage / flow at a suitable temperature? | The hot water supply temperature from the calorifier was correct, being at 60°C |
| Return Temperature (°C): | 51.5 | Is the calorifier return at a suitable temperature? | The hot water return temperature to the calorifier was correct, being above 50°C . |

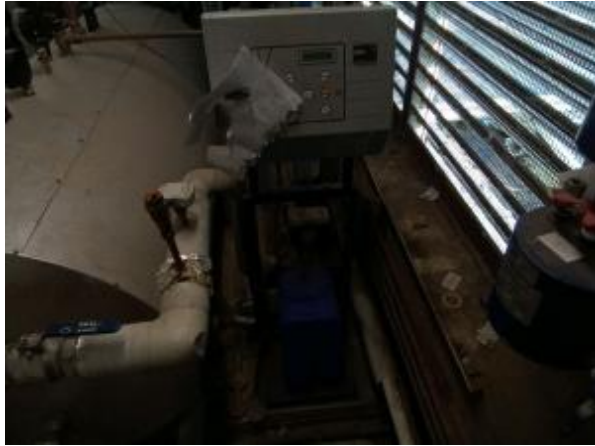
**Example of Plate Heat Exchanger 1**

| Plate heat exchanger serves additional comments: | Two Calorifier cylinders | | | | | | | | | |
